DOT/FAA/AR-97/9

An Acoustic Emission Test for Aircraft Halon 1301 Fire Extinguisher Bottles

April 1998

Final Report

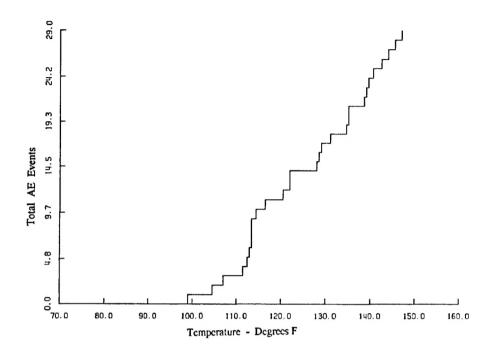
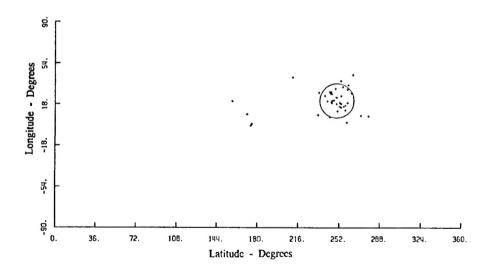
Location diagrams and event versus temperature data are shown in figures 4 and 5. In figure 4, a serious appearing cluster containing 29 events is shown on the location plot. However, the event rate is constant as the temperature, and thus the pressure, increases. In contrast, figure 5 shows a

FIGURE 4. EVENT VERSUS TEMPERATURE CURVE AND LOCATION PLOT. The slope of the event curve for the cluster is constant with increasing temperature.

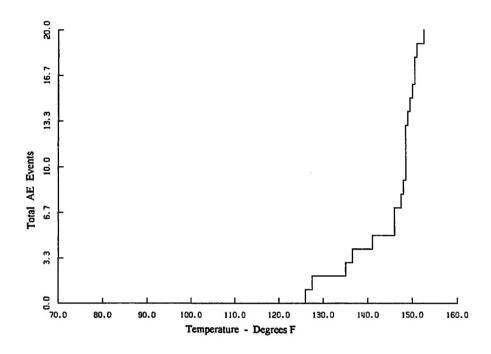
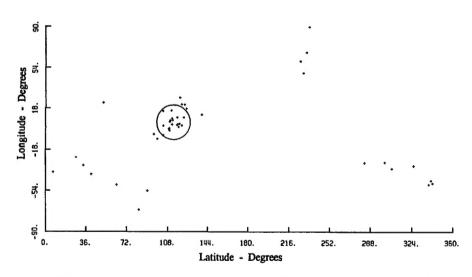
cluster containing 20 events, but 18 of the 20 events occurred above 130°F. The cluster in figure 5 is located partially over a doubler plate on the bottle. An x ray of this plate showed a tungsten inclusion in the fillet weld holding the plate on the bottle. The fact that the emission did not start until a relatively high temperature and the rapid emission rate above 148°F is strong evidence that a crack is propagating in the weld, starting from the tungsten inclusion. Because

FIGURE 5. EVENT VERSUS TEMPERATURE CURVE AND LOCATION PLOT. The slope of the event versus temperature curve for the cluster shows a significant increase at high temperatures.

the bottle passed a hydrostatic test, the crack is probably not in the vessel wall but instead is propagating within the doubler plate fillet weld parallel to the wall. Thus, it is a real flaw but one which may not result in the failure of the bottle.
